**Flood Control Project Maintenance
Levee Inspections**

Fall 2018 Levee Maintenance Deficiency Summary Report

**Flood Control Project Maintenance
Levee Inspections****LMA District Cover Sheet****Fall 2018 Levee Inspection Results****Sutter Maintenance Yard East Levee Sutter Bypass**

Sutter Maintenance Yard East Levee Sutter Bypass

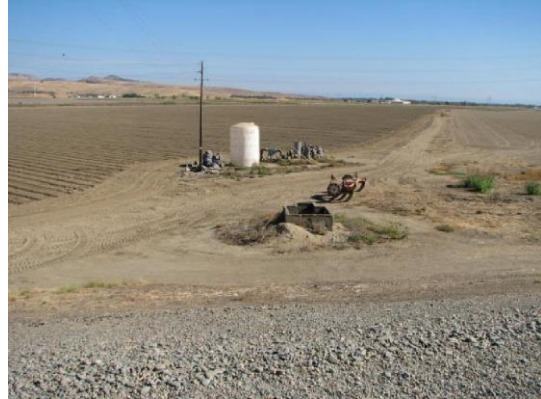
Photo 3 of 3 : UCIP_FA_2018_51560_64803.jpg

Comment Code						
Inspector Comment						
FS_ID:51560 DS_ID:16862 EP_NO: 10932 Repair Type: Non-Urgent Crossing Status: Found UCIP Comments: 4/11/2017 Riser knocked out of place on WS shoulder and no sign of the siphon breaker. Suspect it was buried. (DWR Sutter Yard- A Freitag)10/10/2016 WS CMP riser is still knocked out of place and siphon breaker is suspected to be buried.(DWR Sutter Yard - a Freitag)4/18/2016 CMP riser is still knocked out of place and a siphon breaker cannot be found.5/7/2015 24in. cmp riser and siphon breaker were not found on the WS shoulder.11/12/2014 Same as last inspection.5/13/2014 Same as last inspection.10/30/2013 24in. cmp riser was pulled out of levee and there is no sign of a siphon breaker on WS shoulder.5/22/2013 24in. cmp riser on WS shoulder is full of garbage and dirt and should be cleaned out to inspect siphon breaker.10/8/2012 Pier has no walkway to access pump on pier. This is not necessarily an issue. FIELD_STRUCT_DESC: 16-inch coated steel irrigation pipe through the levee, 6.3 feet below the crown. Vertical pump mounted on a steel structure on the bank. Siphon breaker in a 24-inch corrugated metal pipe riser on the waterside (WS) slope. Concrete distribution box on the landside (LS). Power and communication joint pole (JP) on the WS shoulder. Original equipment in O&M. Hand drawings available in permit. (Original O&M entry removed in 1975 and replaced under Permit No. 10932, 1976 - Edward Nall) [Additional Reference(s): DWR Levee Log, 2005. USACE Sacramento O&M Manual 315, May 1953 (Station 1094+80)]. FS Date: 4/13/2017 12:49:52 PM

7'X7' concrete distribution box on LS toe.

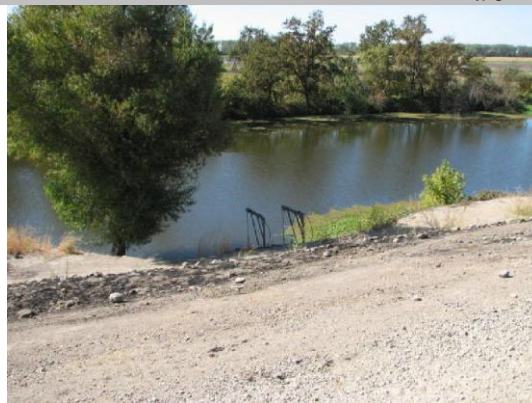
Photo 2 of 3 : UCIP_FA_2018_51566_64814.jpg

Flap gates on WS toe.

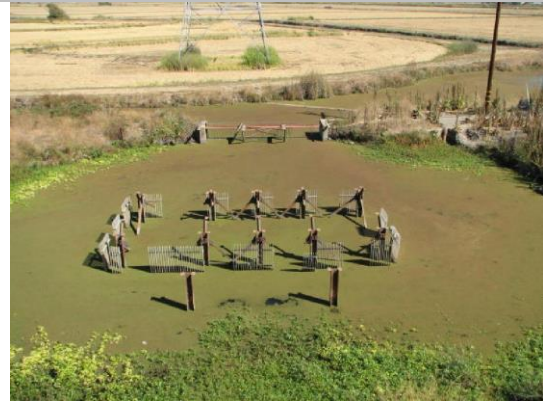
Photo 3 of 3 : UCIP_FA_2018_51566_64813.jpg

Comment Code						
Inspector Comment						
FS_ID:51566 DS_ID:16880 EP_NO: N/A Repair Type: No Action Needed Crossing Status: Found UCIP Comments: 4/11/2017 Not abandoned. good condition. (DWR Sutter Yard- AFreitag)10/10/2016 NOT ABANDONED. The old pumping plant was removed but the culverts are still used as a gravity drain to regulate the water level in the LS ditch.(DWR Sutter Yard - afreitag)4/18/2016 Crossing is in good condition. The culvert is not abandoned and is used as gravity drain for the LS ditch into the bypass channel.5/7/2015 Concrete culverts are still being used as gravity drains for the LS ditch.11/12/2014 Same as last inspection.5/13/2014 Same as last inspection.10/30/2103 Same as last inspection.5/22/2013 Concrete culvert is being used as gravity drain for LS ditch.10/8/2012 Flap gates left in open position. Unable to determine type of abandonment for concrete culverts. Contact inspector to determine type of abandonment. FIELD_STRUCT_DESC: *ABANDONED* [Pumping Plant No. 3] 1 of 2: 48-inch by 72-inch reinforced concrete drainage culvert through the levee, 30 feet below the crown. Slide gate in concrete well on the landside (LS) shoulder. Wood flap gate and concrete headwall on the waterside (WS) end. Abandoned State pumping plant on the LS. [Additional Reference(s): DWR Levee Log, 2005. USACE Sacramento O&M Manual 315, May 1953 (Station 966+30)]. FS Date: 4/13/2017 1:10:49 PM

Abandoned pump house and sump on LS toe.

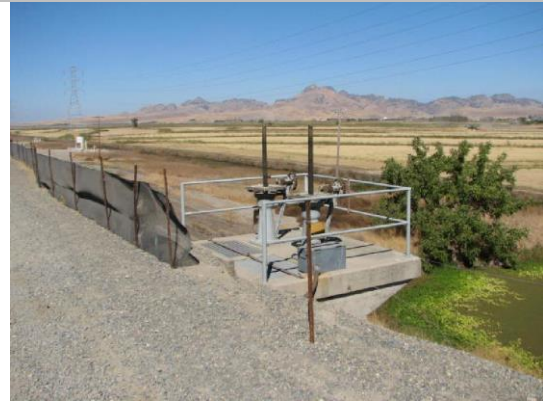
Photo 1 of 3 : UCIP_FA_2018_51567_64819.jpg

Slide gate valves on LS shoulder.

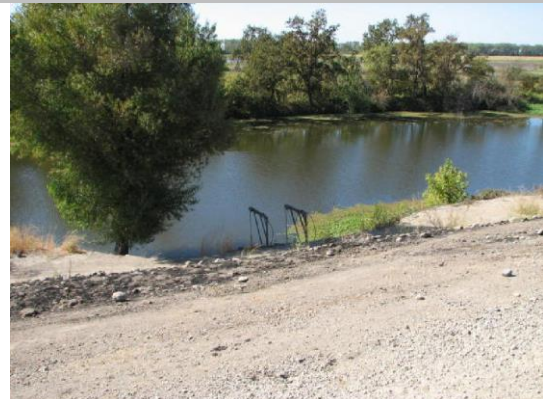
Photo 2 of 3 : UCIP_FA_2018_51567_64818.jpg

Flap gates on WS toe.

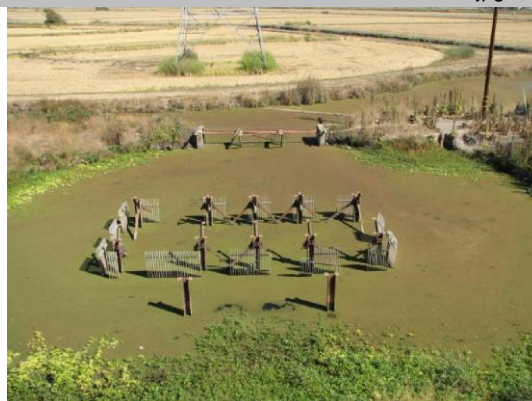
Photo 3 of 3 : UCIP_FA_2018_51567_64817.jpg

Comment Code						
Inspector Comment						
FS_ID:51567 DS_ID:16895 EP_NO: N/A Repair Type: No Action Needed Crossing Status: Found UCIP Comments: 4/11/2017 Not abandoned. Good condition. (DWR Sutter Yard- AFreitag)10/10/2016 NOT ABANDONED. The old pumping plant was removed but the culverts are still used as a gravity drain to regulate the water level in the LS ditch.(DWR Sutter Yard - afreitag)4/18/2016 Crossing is in good condition. The culvert is not abandoned and is used as gravity drain for the LS ditch into the bypass channel.5/7/2015 Concrete culverst still being used as gravity drains for LS ditch.11/12/2014 Same as last inspection.5/13/2014 Same as last inspection.10/30/2103 Same as last inspection.5/22/2013 Concrete culvert is being used as gravity drain for LS ditch.10/8/2012 Flap gates in open position. Need to determine type of abandonment. Contact inspector to determine abandonment. FIELD_STRUCT_DESC: *ABANDONED* [Pumping Plant No. 3] 2 of 2: 48-inch by 72-inch reinforced concrete drainage culvert through the levee, 30 feet below the crown. Slide gate in concrete well on the landside (LS) shoulder. Wood flap gate and concrete headwall on the waterside (WS) end. Abandoned State pumping plant on the LS. [Additional Reference(s): DWR Levee Log, 2005. USACE Sacramento O&M Manual 315, May 1953 (Station 966+30)]. FS Date: 4/13/2017 1:16:13 PM

Abandoned pump house and sump on LS toe.

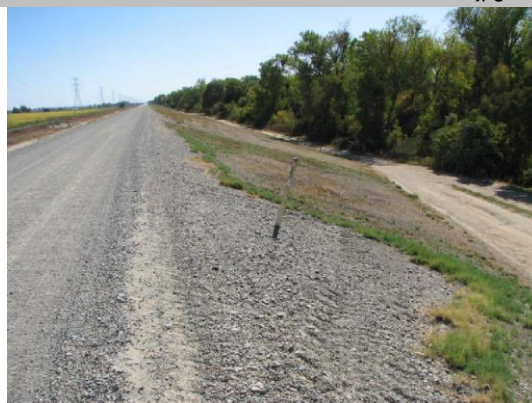
Photo 1 of 3 : UCIP_FA_2018_51582_65213.jpg

Comment Code						
Inspector Comment						
FS_ID:51582 DS_ID:19985 EP_NO: N/A Repair Type: Non-Urgent Crossing Status: Found UCIP Comments: 4/11/2017 Crossing appears to be in good condition. (DWR Sutter Yard- AFreitag)10/10/2016 Crossing appears to be in good condition.(DWR Sutter Yard - afreitag)4/18/2016 Crossing appears in good condition. No noticeable issues to report.5/7/2015 Crossing is in good condition. No noticeable issues to report.11/12/2014 Same as last inspection.5/13/2014 Same as last inspection.10/30/2013 Same as last inspection.5/22/2013 Same as last inspection.10/8/2012 No Permit identified for crossing. FIELD_STRUCT_DESC: Steel gas line of an unknown size crosses the levee at an unknown depth. Carsonite sign located on the waterside (WS) shoulder and at the landside (LS) toe across the toe ditch. Line is owned by Calpine Pipeline Company. No permit has been identified since crossing was field discovered in 2012. FS Date: 4/13/2017 1:56:50 PM

Gasline marker on WS shoulder.

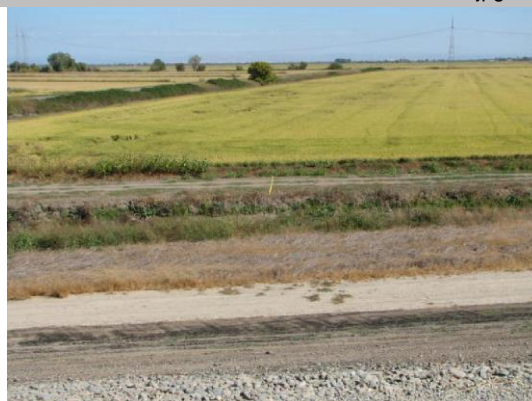
Photo 2 of 3 : UCIP_FA_2018_51582_65212.jpg

Comment Code						
Inspector Comment						
FS_ID:51582 DS_ID:19985 EP_NO: N/A Repair Type: Non-Urgent Crossing Status: Found UCIP Comments: 4/11/2017 Crossing appears to be in good condition. (DWR Sutter Yard- AFreitag)10/10/2016 Crossing appears to be in good condition.(DWR Sutter Yard - afreitag)4/18/2016 Crossing appears in good condition. No noticeable issues to report.5/7/2015 Crossing is in good condition. No noticeable issues to report.11/12/2014 Same as last inspection.5/13/2014 Same as last inspection.10/30/2013 Same as last inspection.5/22/2013 Same as last inspection.10/8/2012 No Permit identified for crossing. FIELD_STRUCT_DESC: Steel gas line of an unknown size crosses the levee at an unknown depth. Carsonite sign located on the waterside (WS) shoulder and at the landside (LS) toe across the toe ditch. Line is owned by Calpine Pipeline Company. No permit has been identified since crossing was field discovered in 2012. FS Date: 4/13/2017 1:56:50 PM

Gasline marker on LS toe east of ditch.

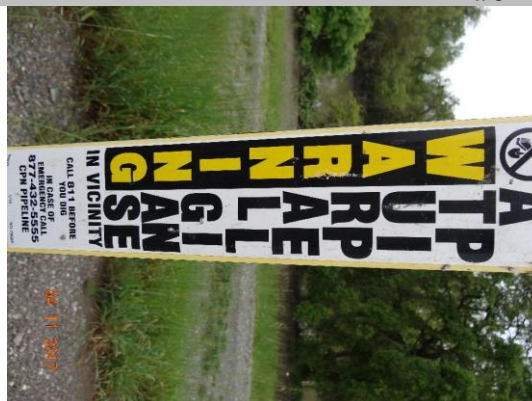
Photo 3 of 3 : UCIP_FA_2018_51582_76970.jpg

Close up of marker

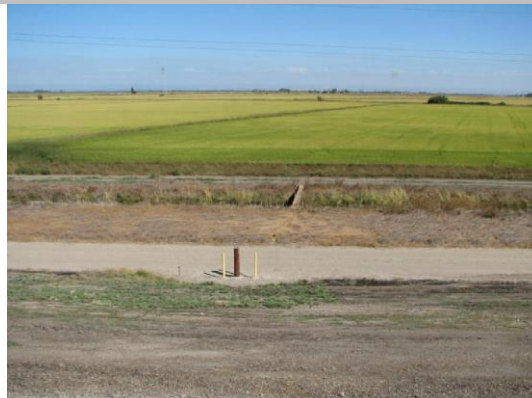
Photo 1 of 2 : UCIP_FA_2018_51583_65215.jpg

Pipe at steel i-beam crossing in ditch at LS toe.

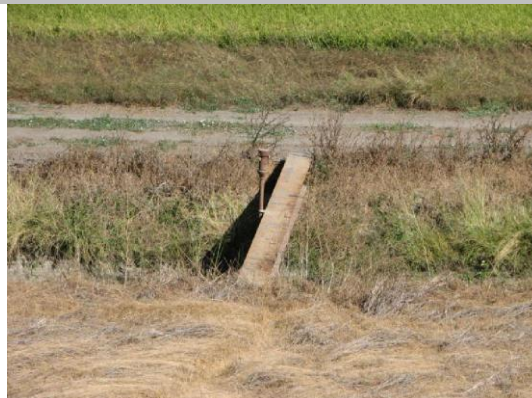
Photo 2 of 2 : UCIP_FA_2018_51583_65214.jpg

Pipe at steel i-beam crossing in ditch at LS toe.

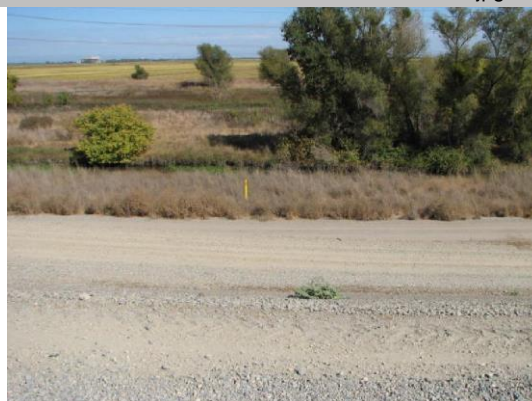
Photo 1 of 3 : UCIP_FA_2018_53446_65217.jpg

FS_ID:53446
DS_ID:16884
EP_NO: 14455
Repair Type: Non-Urgent
Crossing Status: Indicator Found
UCIP Comments: 10/04/2018 Crossing has been downgraded from Urgent to Non-Urgent. Slopes are stable. WS toe was stabilized with rock. Need to contact utility owner to determine the status of the line. Unable to determine if the line is abandoned or active therefore crossing remains classified as a Non-Urgent issue. (O. Magana - DWR UCIP)
4/11/2017 The damage to the levee toe was repaired by Sutter Maintenance Yard. The hole was filled in and compacted with rock. The repairs have not yet been made to the gas line by the gas line owners but the damage does not affect the integrity of the levee or bank. Photos updated. (DWR Sutter Yard- AFreitag)10/18/2016 it is unknown if the damage to the levee toe from the farmer getting his tractor stuck has been repaired (DWR UCIP - thatch)
10/10/2016 Crossing appears to be in good condition but im not sure if the damaged pipe section at the WS berm was ever repaired. (DWR Sutter Yard - afreitag)4/18/2016 Gas line was damaged at the WS berm due to a farmer getting his tractor stuck. Gas company is aware of the damage and will be doing repairs sometime this summer. Damage should not affect the integrity of the levee. (DWR Sutter Yard - afreitag)5/7/2015 Marker on WS broken. (DWR Sutter Yard - afreitag)11/12/2014 Same as last inspection. (DWR Sutter Yard - afreitag)5/13/2014 Same as last inspection. (DWR Sutter Yard - afreitag)10/30/2013 Same as last inspection. (DWR Sutter Yard - afreitag)5/22/2013 Carsonite marker on WS shoudler is broken and should be replaced. (DWR Sutter Yard - afreitag)

Gasline markers on LS toe .

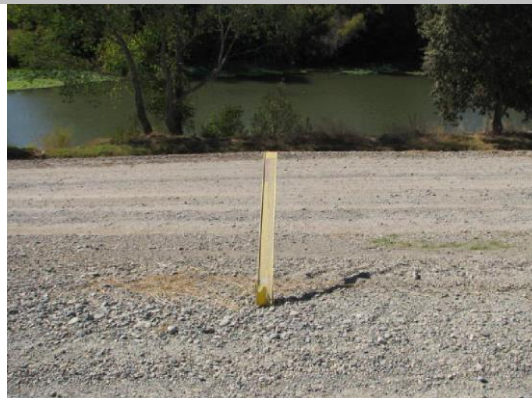
Photo 2 of 3 : UCIP_FA_2018_53446_65216.jpg

FS_ID:53446
DS_ID:16884
EP_NO: 14455
Repair Type: Non-Urgent
Crossing Status: Indicator Found
UCIP Comments: 10/04/2018 Crossing has been downgraded from Urgent to Non-Urgent. Slopes are stable. WS toe was stabilized with rock. Need to contact utility owner to determine the status of the line. Unable to determine if the line is abandoned or active therefore crossing remains classified as a Non-Urgent issue. (O. Magana - DWR UCIP)
4/11/2017 The damage to the levee toe was repaired by Sutter Maintenance Yard. The hole was filled in and compacted with rock. The repairs have not yet been made to the gas line by the gas line owners but the damage does not affect the integrity of the levee or bank. Photos updated. (DWR Sutter Yard - A Freitag) 10/18/2016 it is unknown if the damage to the levee toe from the farmer getting his tractor stuck has been repaired (DWR UCIP - thatch)
10/10/2016 Crossing appears to be in good condition but im not sure if the damaged pipe section at the WS berm was ever repaired. (DWR Sutter Yard - a Freitag) 4/18/2016 Gas line was damaged at the WS berm due to a farmer getting his tractor stuck. Gas company is aware of the damage and will be doing repairs sometime this summer. Damage should not affect the integrity of the levee. (DWR Sutter Yard - a Freitag) 5/7/2015 Marker on WS broken. (DWR Sutter Yard - a Freitag) 11/12/2014 Same as last inspection. (DWR Sutter Yard - a Freitag) 5/13/2014 Same as last inspection. (DWR Sutter Yard - a Freitag) 10/30/2013 Same as last inspection. (DWR Sutter Yard - a Freitag) 5/22/2013 Carsonite marker on WS shoudler is broken and should be replaced. (DWR Sutter Yard - a Freitag)

Gasline markers on WS shoulder.

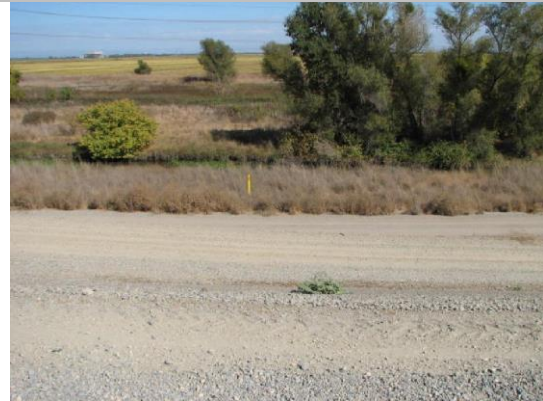
Photo 1 of 3 : UCIP_FA_2018_53447_65219.jpg

Comment Code						
Inspector Comment						
FS_ID:53447 DS_ID:16899 EP_NO: 14455 Repair Type: Non-Urgent Crossing Status: Indicator Found UCIP Comments: 10/04/2018 Crossing has been downgraded from Urgent to Non-Urgent. Slopes are stable. WS toe was stabilized with rock. Need to contact utility owner to determine the status of the line. Unable to determine if the line is abandoned or active therefore crossing remains classified as a Non-Urgent issue. (O. Magana - DWR UCIP) 4/11/2017 The damage to the levee toe was repaired by Sutter Maintenance Yard. The hole was filled in and compacted with rock. The repairs have not yet been made to the gas line by the gas line owners but the damage does not affect the integrity of the levee or bank. Photos Updated. (DWR Sutter Yard- AFreitag)10/18/2016 it is unknown if the damage to the levee toe from the farmer getting his tractor stuck has been repaired (DWR UCIP - thatch) 10/10/2016 Crossing appears to be in good condition but im not sure if the damaged pipe section at the WS berm was ever repaired. (DWR Sutter Yard - afreitag)4/18/2016 Gas line was damaged at the WS berm due to a farmer getting his tractor stuck. Gas company is aware of the damage and will be doing repairs sometime this summer. Damage should not affect the integrity of the levee. (DWR Sutter Yard - afreitag)5/7/2015 Marker on WS broken. (DWR Sutter Yard - afreitag)11/12/2014 Same as last inspection. (DWR Sutter Yard - afreitag)5/13/2014 Same as last inspection. (DWR Sutter Yard - afreitag)10/30/2013 Same as last inspection. (DWR Sutter Yard - afreitag)5/22/2013 Carsonite marker on WS shoulder is broken and should be replaced. (DWR Sutter Yard - afreitag) FIELD_STRUCT_DESC: 2 of 3: 4.5-inch steel natural gas pipeline through the levee, 2 feet below the crown. Pipes were placed in same trench, 1 foot apart. Gas line markers located on the landside (LS) toe and the waterside (WS) shoulder. Owner listed on markers is California Resources Corporation (CRC) and can be reached in case of emergency at 1-661-763-6363. For dig alert, call 811 or USA North 1-800-227-2600. (underground natural gas pipeline across Sutter Bypass and through both levees authorized under Permit No. 14455, 1986 - Depco, Inc.; name and ownership change for underground natural gas line was authorized under Permit No. 14455-1, 2016 - California Resources Production Cooperation [CRC]). FS Date: 10/4/2018 10:59:00 AM

Gasline markers on LS toe.

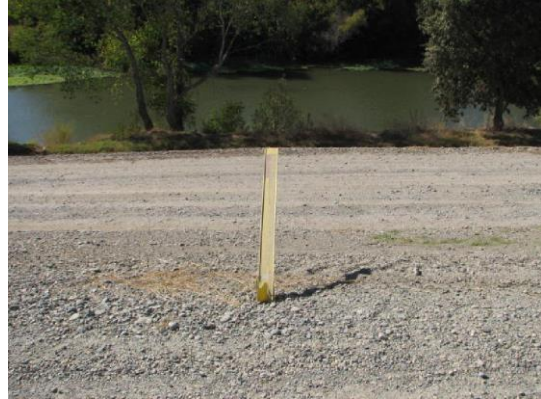
Photo 2 of 3 : UCIP_FA_2018_53447_65218.jpg

FS_ID:53447
DS_ID:16899
EP_NO: 14455
Repair Type: Non-Urgent
Crossing Status: Indicator Found
UCIP Comments: 10/04/2018 Crossing has been downgraded from Urgent to Non-Urgent. Slopes are stable. WS toe was stabilized with rock. Need to contact utility owner to determine the status of the line. Unable to determine if the line is abandoned or active therefore crossing remains classified as a Non-Urgent issue. (O. Magana - DWR UCIP)
4/11/2017 The damage to the levee toe was repaired by Sutter Maintenance Yard. The hole was filled in and compacted with rock. The repairs have not yet been made to the gas line by the gas line owners but the damage does not affect the integrity of the levee or bank. Photos Updated. (DWR Sutter Yard- A Freitag)10/18/2016 it is unknown if the damage to the levee toe from the farmer getting his tractor stuck has been repaired (DWR UCIP - thatch)
10/10/2016 Crossing appears to be in good condition but im not sure if the damaged pipe section at the WS berm was ever repaired. (DWR Sutter Yard - a Freitag)4/18/2016 Gas line was damaged at the WS berm due to a farmer getting his tractor stuck. Gas company is aware of the damage and will be doing repairs sometime this summer. Damage should not affect the integrity of the levee. (DWR Sutter Yard - a Freitag)5/7/2015 Marker on WS broken. (DWR Sutter Yard - a Freitag)11/12/2014 Same as last inspection. (DWR Sutter Yard - a Freitag)5/13/2014 Same as last inspection. (DWR Sutter Yard - a Freitag)10/30/2013 Same as last inspection. (DWR Sutter Yard - a Freitag)5/22/2013 Carsonite marker on WS shoulder is broken and should be replaced. (DWR Sutter Yard - a Freitag)

Gasline markers on WS shoulder.

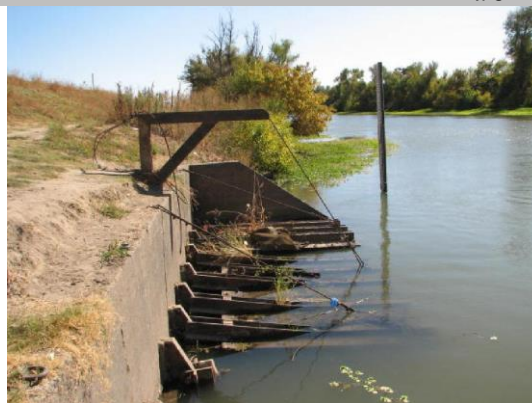
Photo 2 of 3 : UCIP_FA_2018_51595_65250.jpg

Flap gates on WS toe.

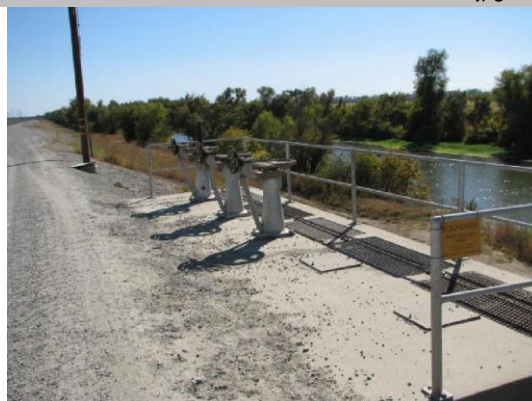
Photo 1 of 3 : UCIP_FA_2018_51596_65254.jpg

Slide gates on WS shoulder.

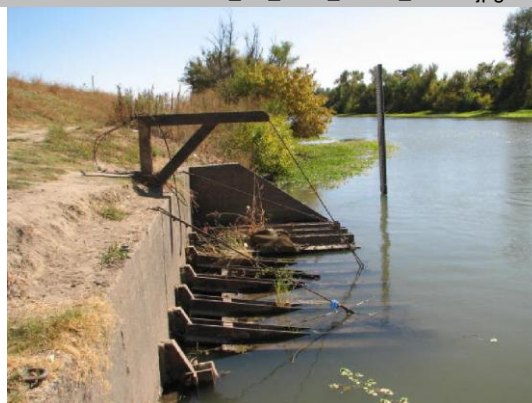
Photo 2 of 3 : UCIP_FA_2018_51596_65253.jpg

Flap gates on WS toe.

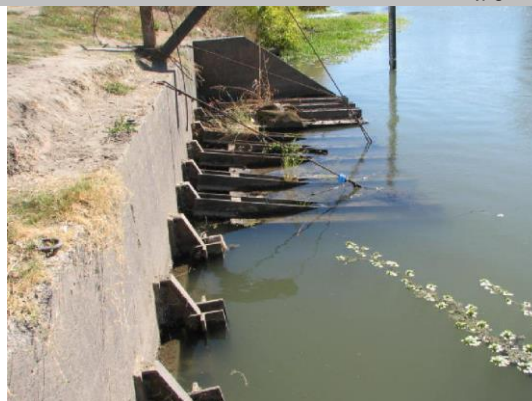
Photo 2 of 3 : UCIP_FA_2018_51597_65256.jpg

Flap gates on WS toe.

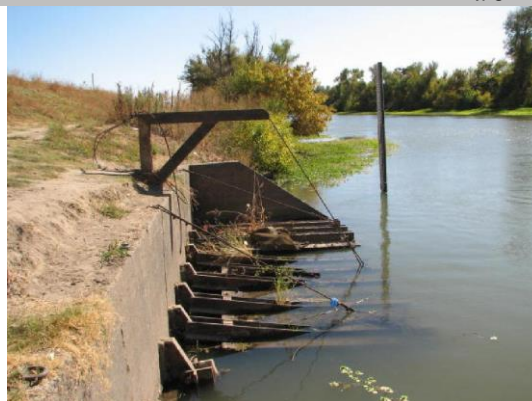
Photo 2 of 3 : UCIP_FA_2018_51598_65259.jpg

Flap gates on WS toe.

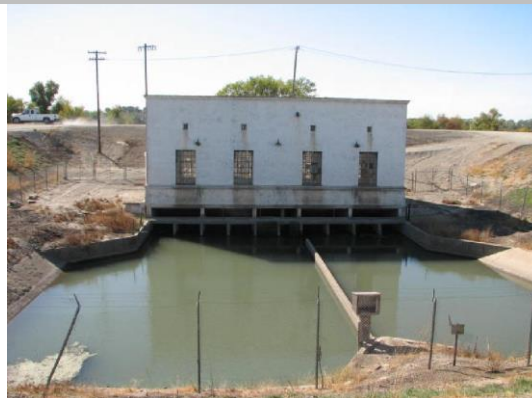
Photo 3 of 3 : UCIP_FA_2018_51599_65261.jpg

FIELD_STRUCT_DESC: *ABANDONED* [Pumping Plant No. 2] 5 of 5: 48-inch by 72-inch reinforced concrete drainage culvert through the levee, 31.5 feet below the crown. Slide gate in concrete well on the waterside (WS) shoulder. Wood flap gate and concrete headwall on the WS end. Wooden steps on the landside (LS) slope. Concrete steps on the WS end. [Additional Reference(s): DWR Levee Log, 2005. USACE Sacramento O&M Manual 315, May 1953 (Station 582+19)].						
FS Date: 4/13/2017 2:20:32 PM

Pumphouse/intake on LS toe.

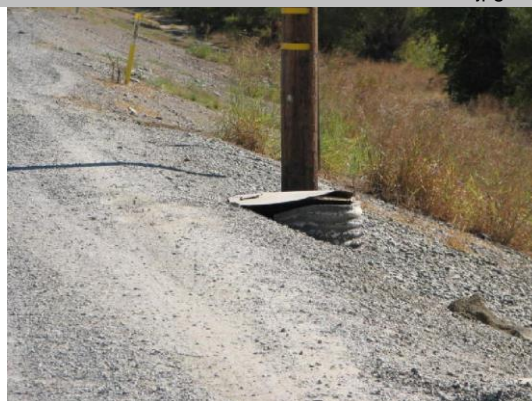
Photo 1 of 1 : UCIP_FA_2018_51600_65264.jpg

Comment Code						
Inspector Comment						
FS_ID:51600 DS_ID:16872 EP_NO: 3165 Repair Type: Non-Urgent Crossing Status: Found UCIP Comments: 4/11/2017 Abandoned. 10/10/2016 Abandoned crossing. (DWR Sutter Yard - afreitag)4/18/2016 Abandoned crossing but no noticebale issues to report.5/7/2015 Abandoned crossing. No noticeable issues to report.11/12/2014 Same as last inspection.5/13/2014 Same as last inspection.10/30/2013 Same as last inspection.5/22/2013 Same as last inspection.10/8/2012 Need to determine type of abandonment. FIELD_STRUCT_DESC: *ABANDONED* 10-inch drainage pipe through the levee, 2 feet below the crown. Siphon breaker in a 36-inch corrugated metal pipe (CMP) riser on the waterside (WS) shoulder. Flap gate on the WS end. Minimalistic design drawings available. (Permit No. 3165, 1959 - State of California Department of Water Resources [DWR]). [Additional Reference(s): DWR Levee Log, 2005]. FS Date: 4/13/2017 2:21:21 PM

Siphon breaker in 36-inch CMP riser on WS shoulder. Pipe visible at siphon breaker.

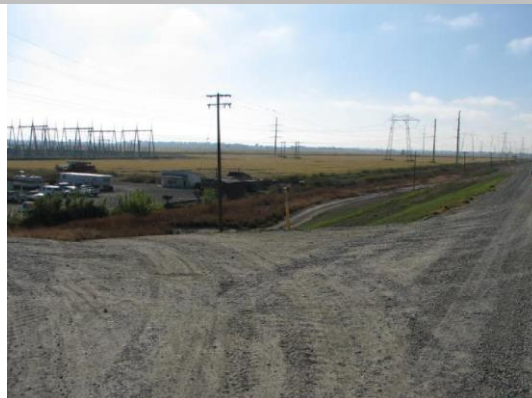
Photo 1 of 3 : UCIP_FA_2018_51601_65266.jpg

Gasline marker on LS shoulder.

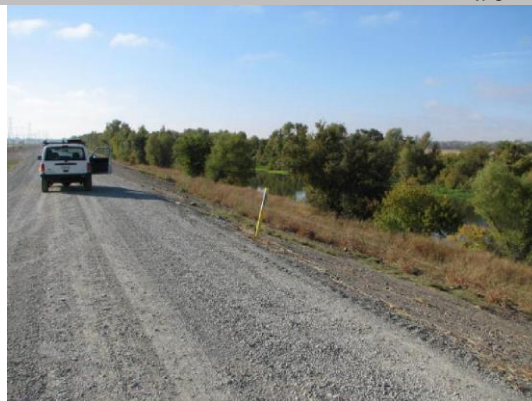
Photo 2 of 3 : UCIP_FA_2018_51601_65265.jpg

Gasline marker on WS shoulder.

Comment Code						
Inspector Comment						
FS_ID:51601 DS_ID:19986 EP_NO: N/A Repair Type: Non-Urgent Crossing Status: Indicator Found UCIP Comments: 4/11/2017 Crossing appears to be in good condition. (DWR Sutter Yard - A Freitag)10/10/2016 Crossing appears to be in good condition but there is no permit on file.(DWR Sutter Yard - a Freitag)4/18/2016 Crossing appears in good condition. No noticeable issues to report.5/7/2015 Crossing is in good condition. No noticeable issues to report.11/12/2014 Same as last inspection.5/13/2014 Same as last inspection.10/30/2013 Same as last inspection.5/22/2013 Same as last inspection.10/9/2012 No permit identified for crossing. FIELD_STRUCT_DESC: Gas pipeline of an unknown size or material crosses the levee, at an unknown depth. Carsonite signs on both the landside (LS) and the waterside (WS) shoulder. Pipeline is owned by Calpine Pipeline Company. No permit has been identified since crossing was field discovered in 2012. FS Date: 4/13/2017 2:21:49 PM

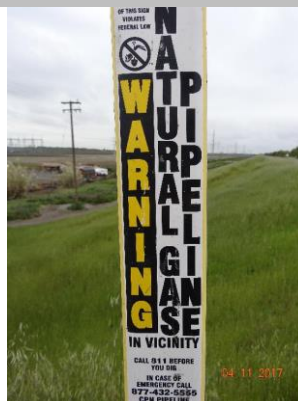
Photo 3 of 3 : UCIP_FA_2018_51601_76971.jpg

Close up of marker

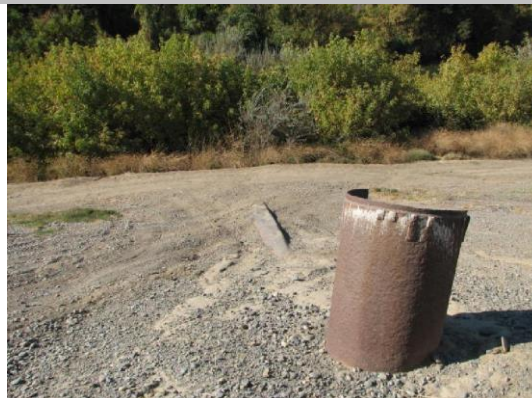
Photo 1 of 3 : UCIP_FA_2018_51605_65314.jpg

Comment Code						
Inspector Comment						
FS_ID:51605 DS_ID:16875 EP_NO: N/A Repair Type: Non-Urgent Crossing Status: Found UCIP Comments: 4/11/2017 Abandoned. (DWR Sutter Yard-AFreitag)10/10/2016 Abandoned crossing.(DWR Sutter Yard -afreitag)4/18/2016 Abandoned crossing.5/7/2015 Abandoned crossing. Needs to be properly abandoned.11/12/2014 Same as last inspection.5/14/2014 Same as last inspection.10/30/2013 Same as last inspection.5/23/2013 Same as last inspection.10/9/2012 Pipe has not been abandoned properly. It should be removed from the levee section. FIELD_STRUCT_DESC: 16-inch steel irrigation pipe through the levee, 3.5 feet below the crown. Siphon breakers in 30-inch steel risers on both the waterside (WS) and the landside (LS) shoulders. Vertical pump on pile structure in stream (removed). [Additional Reference(s): DWR Levee Log, 2005. USACE Sacramento O&M Manual 315, May 1953 (Station 377+10)]. FS Date: 4/13/2017 2:34:10 PM

Pipe on WS slope exposed and crushed below 30-inch steel riser.

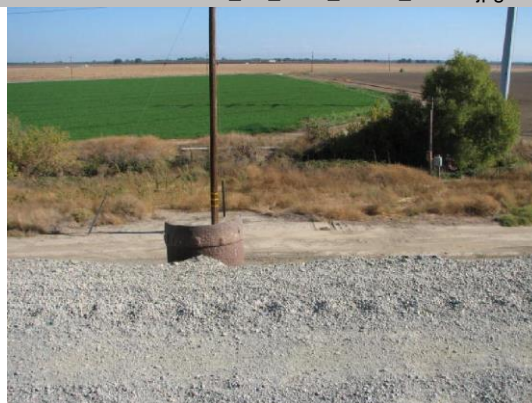
Photo 2 of 3 : UCIP_FA_2018_51605_65313.jpg

Steel riser on LS shoulder.

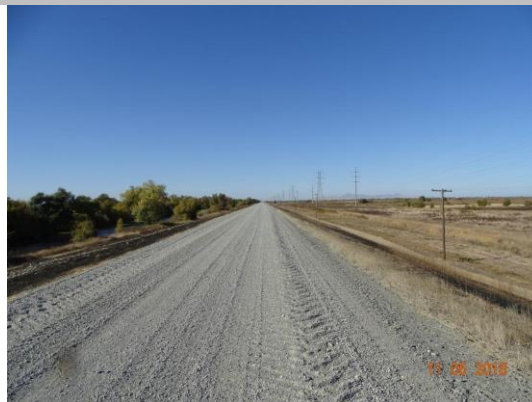
Photo 1 of 1 : FA_2018_ST0002_450_38_20181106_00075.jpg

LM Start	15.30	Rating **	A	Issue No.	38
LM End	15.30	Issue Type +	Ma	Location *	LS
Category	Earthen Levee			GPS Latitude/Longitude	
				Start	End
Item	Vegetation			38.973997 °	38.973997 °
				-121.683283 °	-121.683283 °
DWR ID	DWR_ST0002_01_f_2018_38				
Comment Code					
V1 : Control annual grass and weeds on the levee slopes and easements.					
Inspector Comment					
The vegetation was removed from both slopes.

View of no vegetation on both slopes.

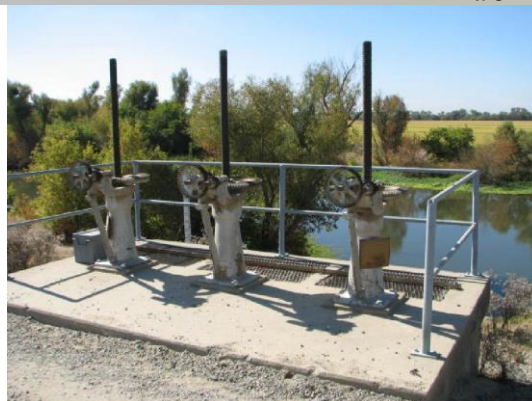
Photo 2 of 3 : UCIP_FA_2018_51609_65325.jpg

UCIP Comments: 4/11/2017 Not abandoned. Good condition. (DWR Sutter Yard - A Freitag)10/10/2016 NOT ABANDONED. The old pumping plant was abandoned but the culverts are still used as a gravity drain to regulate the water level in the LS ditch.(DWR Sutter Yard - a Freitag)4/18/2016 Crossing is in good condition. The culvert is not abandoned and is used as gravity drain for the LS ditch into the bypass channel.5/7/2015 Concrete culvert is being used as a gravity drain for LS ditch.11/12/2014 Same as last inspection.5/14/2014 Same as last inspection.10/30/2013 Same as last inspection.5/23/2013 Concrete culvert is being used as gravity drain for LS ditch.10/9/2012 Determine type of abandonment for concrete culvert.

Slide gates on WS shoulder.

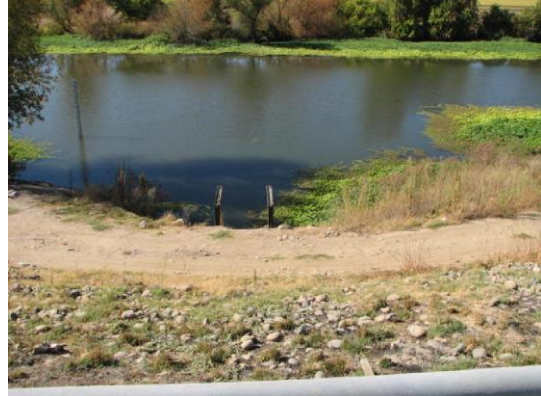
Photo 3 of 3 : UCIP_FA_2018_51609_65327.jpg

Flap gates on WS toe.

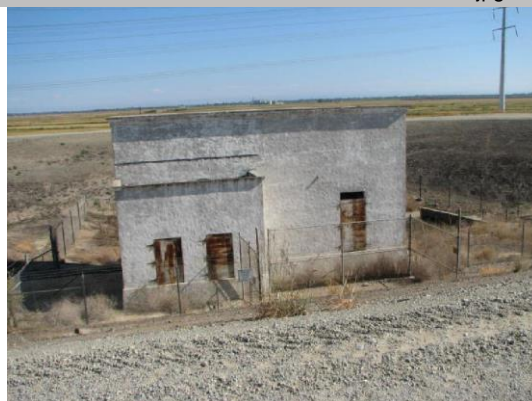
Photo 1 of 3 : UCIP_FA_2018_51610_65330.jpg

Pumphouse on LS toe.

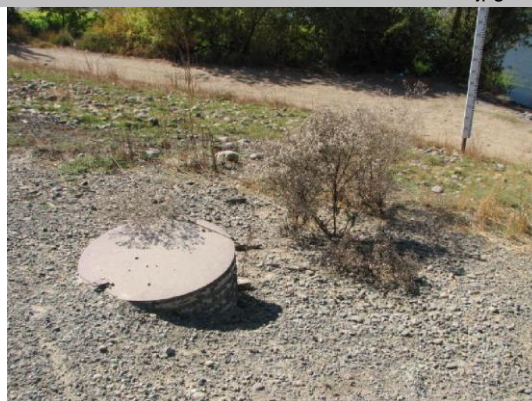
Photo 1 of 1 : UCIP_FA_2018_51612_65334.jpg

Comment Code						
Inspector Comment						
FS_ID:51612 DS_ID:16878 EP_NO: 3165 Repair Type: Non-Urgent Crossing Status: Found UCIP Comments: 4/11/2017 Abandoned. (DWR Sutter Yard-AFreitag)10/10/2016 Abandoned crossing. (DWR Suter Yard-afreitag)4/18/2015 Abandoned crossing. No noticeable issues to report.5/7/2015 Abandoned crossing. No noticeable issues to report.11/12/2014 Same as last inspection.5/14/2014 Same as last inspection.10/30/2013 Same as last inspection.5/23/2013 Same as last inspection.10/9/2012 Need to determine type of abandonment. FIELD_STRUCT_DESC: *ABANDONED* 10-inch steel drainage pipe through the levee, 4 feet below the crown. Siphon breaker in 36-inch corrugated metal pipe (CMP) riser unit on the waterside (WS) shoulder. Flap gate on the WS end. (Permit No. 3165, 1959 - State of California, Department of Water Resources [DWR]) [Additional Reference(s): DWR Levee Log, 2005]. FS Date: 4/13/2017 2:51:29 PM

36-inch CMP riser on WS shoulder.
